# Wairoa Cyclone Gabrielle Review

Prepared for – Wairoa District Council

APRIL 4, 2024

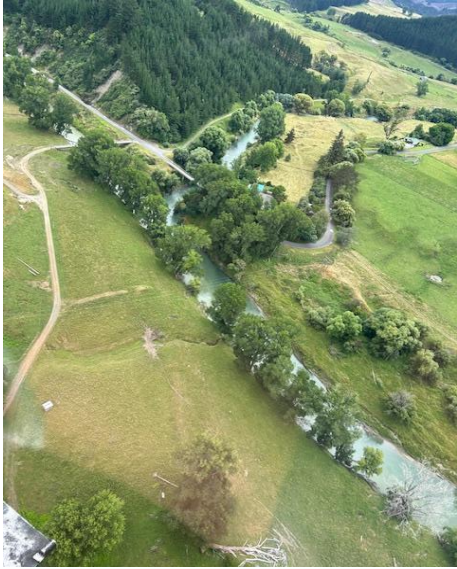
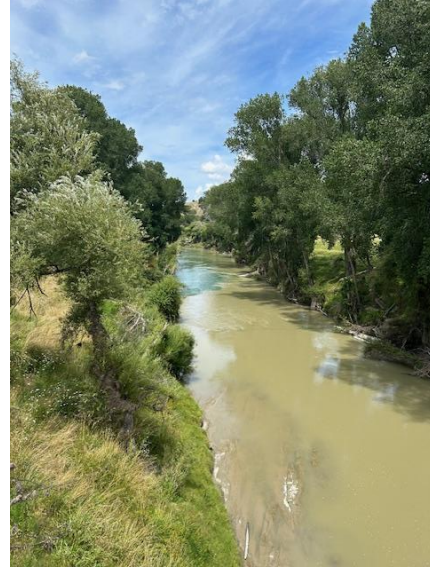
*Figures 8. & 9. Poplars Waikaretaheke Waiau Confluence*

As the major tributaries i.e., Waiau and Wairoa exit the foothills, and traverse the floodplain, the prevalence of very large poplars on and adjacent to the riverbanks is significant.

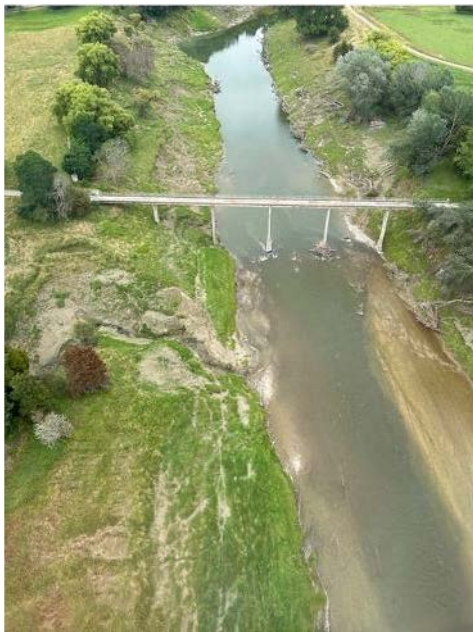
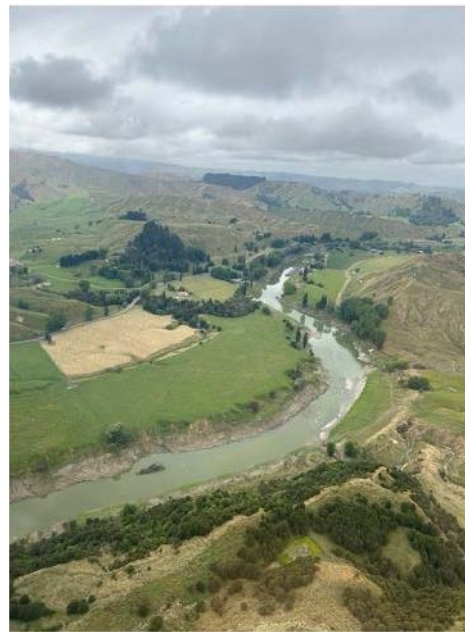
*Figures 10. & 11. Wairoa River post Gabrielle- significant bank modification*

Hangaroa, Wairoa and Mangapoike rivers with additional silt having originated from slip failure in the adjacent hill country, from both land that is farmed and has been afforested. Figures 10 and 11 on the Wairoa River show riverbanks that have been scoured of both silt and trees, whereas figures 8 and 9 on the Waiau show intact poplars and silt aggregation around the poplars. Figure 18 shows slip damage on both Farm and Forestland.

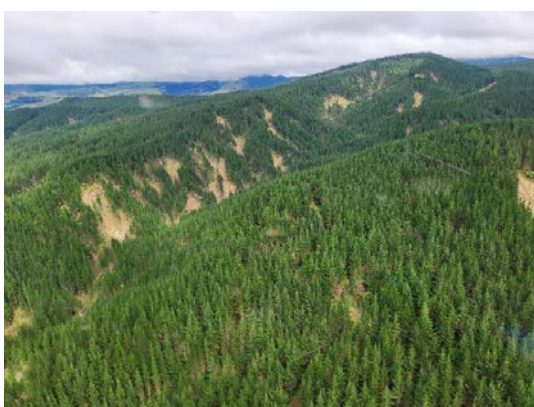
Figure 17. 'Mid slope failure Waikare Forest

Damage in the Waikare Forest is significant and in particular involves ‘mid-slope failure’ and the loss of 10–12-year-old trees in their entirety.

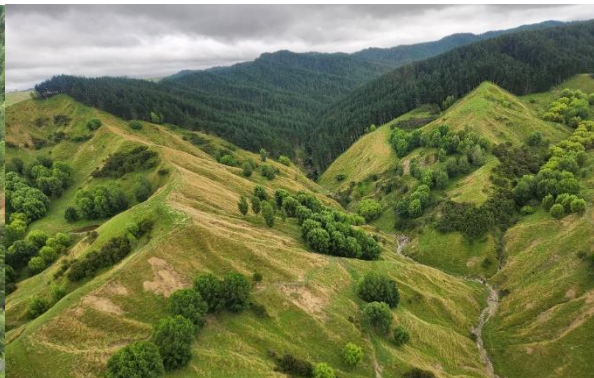
Figure 20. Intact Forest/Farmland near Frasertown

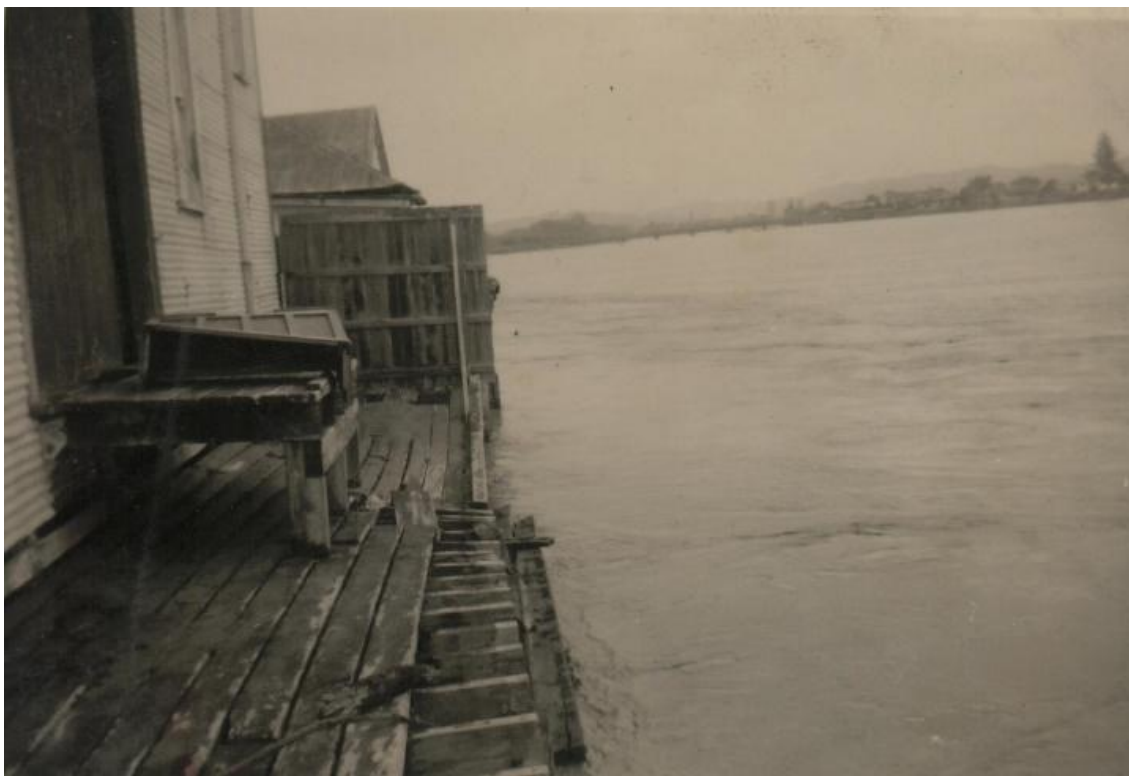
Figure 23. North Clyde and Wairoa River 1948

There is strong repeated evidence of significant flooding of North Clyde since the establishment of the Wairoa Township. Documented events include 1911, 1948, 1988 and now 2023.

The 1948 storm was analysed in detail as part of HBRCs development of flood mitigation options for Wairoa through the late 1990's to early 2000's. The analysis undertaken by Gary Clode<sup>12</sup> in 1994 continues to provide an excellent baseline for understanding 'flood behaviour' and has been referenced in the work currently being undertaken by WSP on flood risk mitigation options for Wairoa. Because of this analysis, referenced in subsequent HBRC reports thereafter, the 1948 event scale with a peak flow rate of 8,200 cumecs was identified as a 1 in 100-year event by the Ministry of Works and Developments 1987 report titled SH38 Waiiau River Flooding. Noting however that there was an allowance for a wide margin of error in the flow estimate of plus/minus 35%. The most up to date preliminary estimates for a 1 in 100-year event now suggest a lower peak flow number of 6,700 cumecs in a 1 in 100-year event based on 'current climate conditions' versus the estimated 8,200 cumecs derived in 1994<sup>13</sup>. Post 1994, a flood model incorporating elements of this work and updated Lidar data was developed and reported in 2006 showing the extent of flood water forecast from a 1 in 100-year event (see figure 23).
