JNL Safety Alert #050

Incident: Property Damage

Reference: 20180919-GF-DAM-001

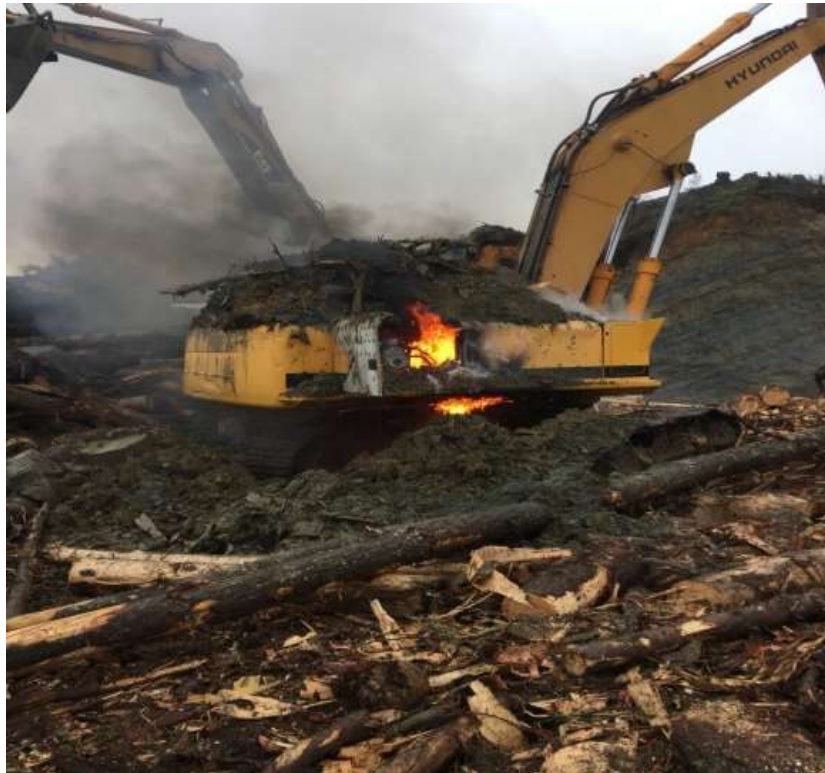
On the 19th of September 2018, at approximately 3.00pm a hired excavator processor caught fire on a skid site in Waituna Forest, Kiwi Rd. The fire started behind the cab of the excavator and was not noticed by the operator until the fire was well alight; the operator was able to escape the cab without injury. A number of forest engineering contractors arrived shortly after and assisted the people on site using fire extinguishers. The crew on site attempted to smother the blaze with an excavator which slowed the rate of spread. The fire was eventually extinguished using a fire engine which arrived on site approximately 1hr and 30minutes after the fire was notified.

Any plant bought into the forest needs to be inspected prior to starting work, this may have identified the problem prior to work commencing. Weather conditions at the time of the incident were wet with high humidity; therefore machine fires can start at any time. Anecdotal industry evidence suggests that this make and model of machine is susceptible to machine fires.

- Machines must be thoroughly inspected before being put into service especially if they are in a used condition
- Keep radiators clean
- Keep engine and radiators clear of debris through regular cleaning.
- Check that battery terminals are tight and clean
- Check all internal hose fitting especially around high heat areas and replace if required.
- All Machinery to be equipped with adequate and in test Fire Extinguishers:
 - 9kg Dry Powder
 - 9lt FoamAs a minimum
- Wash machines out on a regular basis (4 monthly as a minimum).
